# PARKS

AN INTERNATIONAL JOURNAL FOR MANAGERS OF NATIONAL PARKS, HISTORIC SITES, AND OTHER PROTECTED AREAS

Volume 2 Number 4 January, February, March 1978

| W. BROWN MORTON III | 1 | The Preservation of Borobudur, Indonesia |

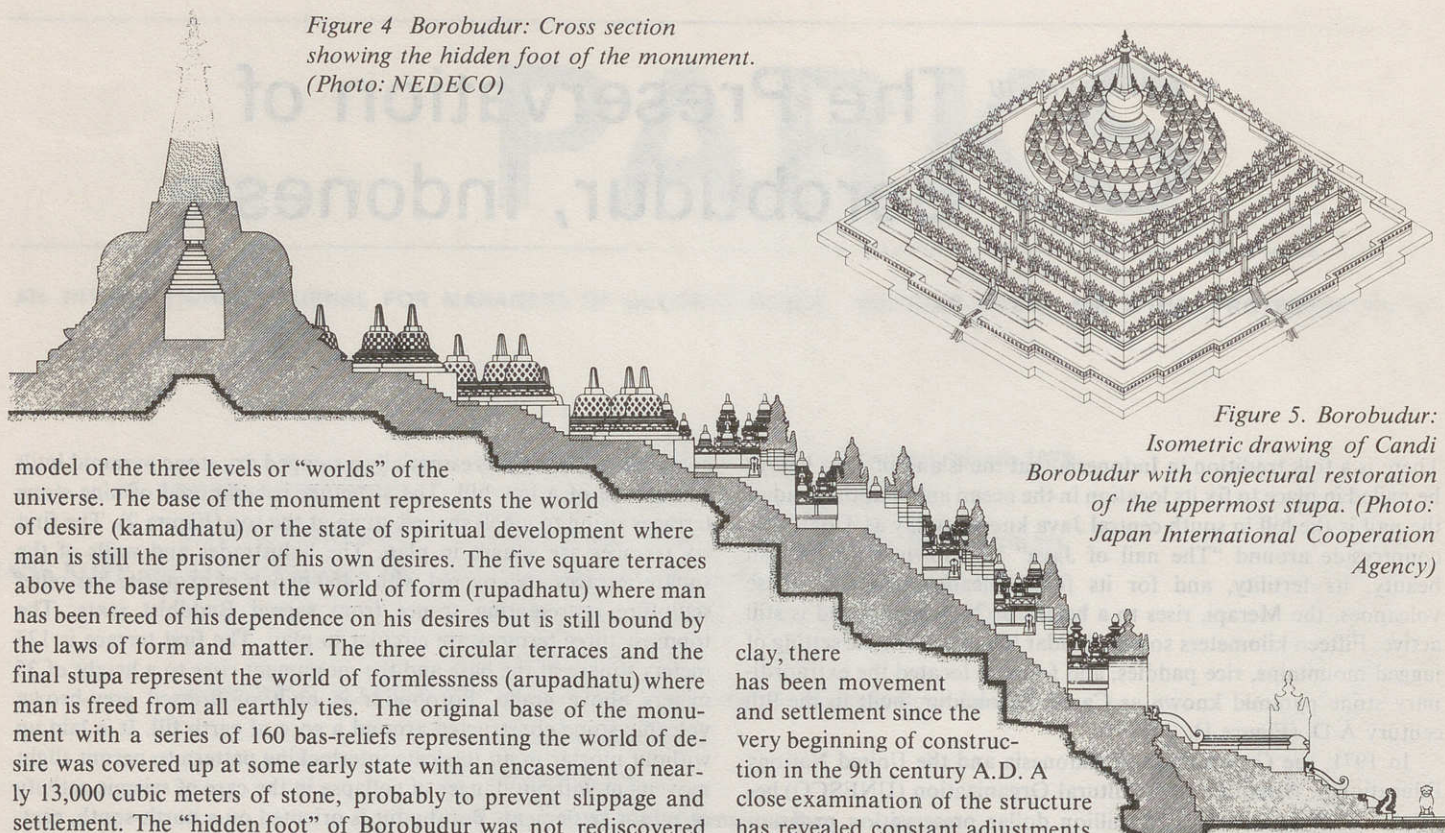
Figure 4 Borobudur: Cross section showing the hidden foot of the monument. (Photo: NEDECO)

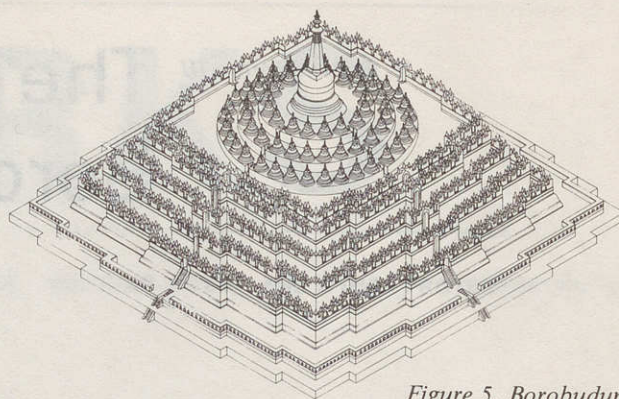
Figure 5. Borobudur: Isometric drawing of Candi Borobudur with conjectural restoration of the uppermost stupa. (Photo: Japan International Cooperation Agency)

model of the three levels or "worlds" of the universe. The base of the monument represents the world of desire (kamadhatu) or the state of spiritual development where man is still the prisoner of his own desires. The five square terraces above the base represent the world of form (rupadhatu) where man has been freed of his dependence on his desires but is still bound by the laws of form and matter. The three circular terraces and the final stupa represent the world of formlessness (arupadhatu) where man is freed from all earthly ties. The original base of the monument with a series of 160 bas-reliefs representing the world of desire was covered up at some early state with an encasement of nearly 13,000 cubic meters of stone, probably to prevent slippage and settlement. The "hidden foot" of Borobudur was not rediscovered until 1885. Portions of the original bas-reliefs have now been exposed to view (Figure 4). The square terraces of the world of form have narrow walkways encircling the pyramid. These walkways are flanked by high ornate stone balustrades which carry the sculptured panels and support hundreds of niches, each containing a statue of a seated Buddha. The ornate decoration of these terraces and the visual and physical confinement of the terrace walkways reinforce the symbolism of "rupadhatu" and give Borobudur its essential character when seen from a distance. At the sixth level, the visitor passes through a small cramped archway and emerges out onto the three upper levels of the monument, into the world of formlessness. The actual experience of this transition is as dramatic as a clap of thunder. The plan of the monument changes from square to circular. The elaborate carved panels and niches cease. The upper terraces are virtually free of decoration. The high confining balustrades vanish and one can see out from horizon to horizon in all directions. One is free. Arranged in quiet repose around the upper terraces are three rings of pierced stone stupas each containing a statue of a seated Buddha. The main stupa at the top of the monument is severely plain and carries no decoration at all. Borobudur is the masterpiece of mahayana Buddhism and one of the outstanding examples of objective religious art (Figure 5).

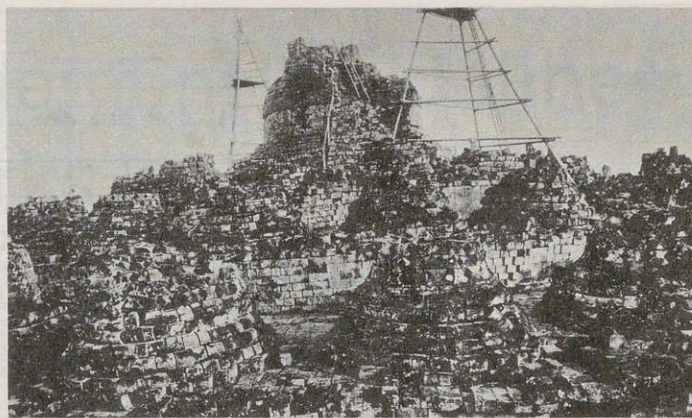
Figure 6. Borobudur: Upper terraces and stupa prior to restoration in 1907. (Photo: BPCB).

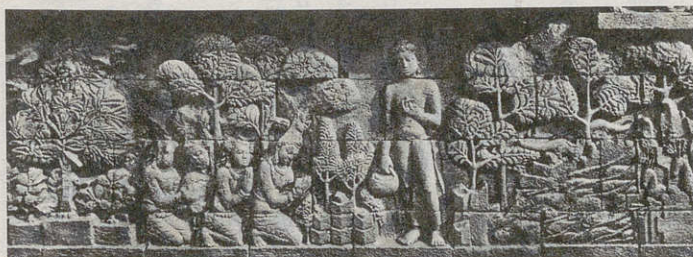
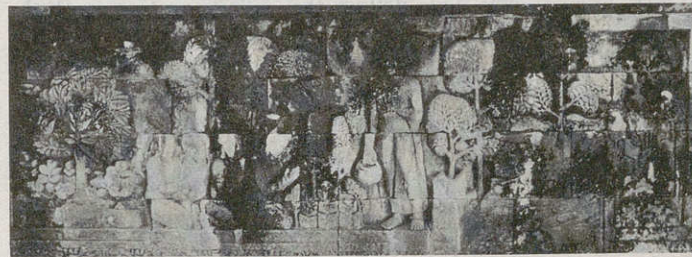
Left, Figure 7. Borobudur: Bas relief sculptured panel showing condition in 1911. (Photo: BPCB) Right, Figure 8. Borobudur: Bas relief sculptured panel showing deteriorated condition in 1969. (Photo: BPCB)

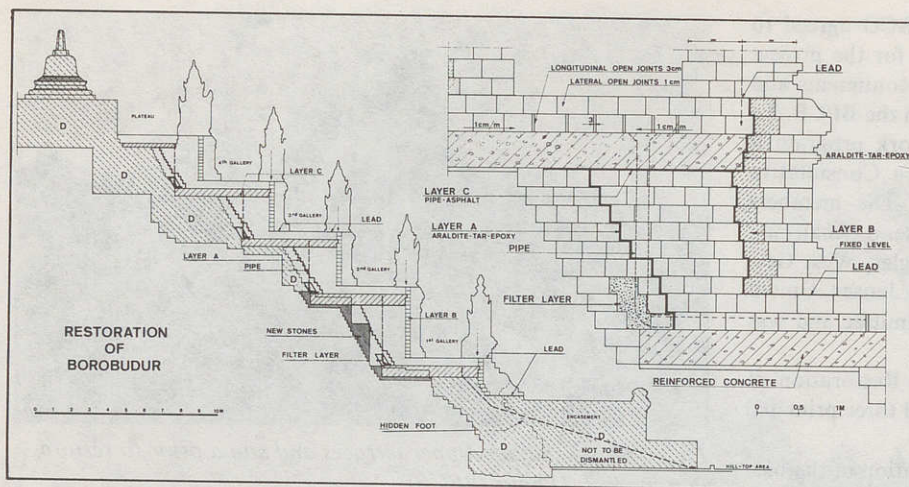
Left, Figure 9. Borobudur: Cross section showing preservation work to be carried out. (Photo: NEDECO). Right, Figure 10. Borobudur: IBM code numbering system for the galleries. (Photo: BPCB).

The basic preservation scheme is shown in Figure 9. The execution of this work requires the removal, treatment, and eventual replacement of all of the outer stones and many of the inner stones of the areas affected. Over 300,000 outer stones alone will be identified and handled individually in the course of the work. In addition to the reinforced concrete slabs installed to evenly distribute the compressive loads, the scheme calls for the installation of a sophisticated series of waterproof layers. Layer A is a layer of Araldite-tar-epoxy painted over the surface of reset inner stones to

prevent seepage between the filled earth core of the monument and the outer stones. Layer B is a vertical layer of treated inner stones covered with Araldite-tar-epoxy set two courses behind the outer decorated stones to prevent moisture moving through the decorated stones by means of capillary action. Layer C is a layer of asphalt on the underside of the new reinforced concrete slabs. There is also a system of hidden drain pipes installed flush with the concrete slabs and beneath the open joints of the relaid terrace floors to carry away rainwater run-off. A filter layer of volcanic sand to aid in drainage is also provided within the wall at each terrace level.

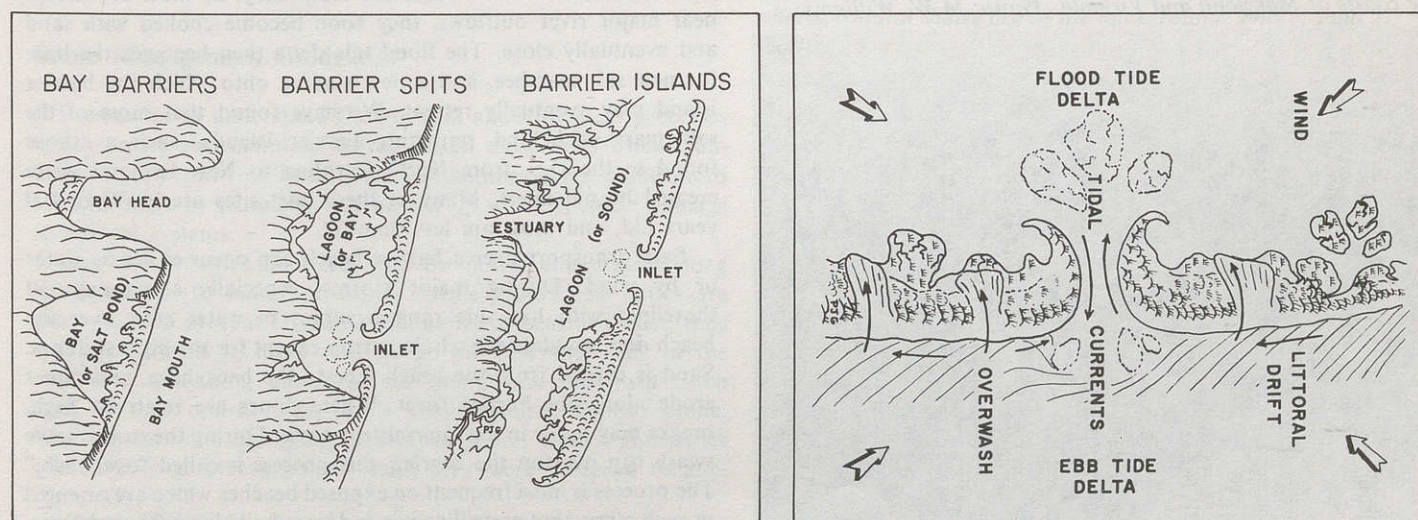
*Left, Figure 1. Types of barrier beaches showing the three basic ways sand, gravel, or other wave-transported sediments are deposited to form barriers which protect a lagoon and/or marsh system from direct ocean wave attack. Bay barriers are connected at each end to the mainland; barrier spits are attached at one end with an inlet at the opposite end, or grow across open water; barrier islands are separated from each other by inlets at both ends. Right, Figure 2. Movement of sand along a barrier beach, and through it or over it, is caused by waves (littoral drift), tides (tidal currents), or storm surges (overwash). Wind also moves sand.*

A barrier beach refers to a sandy structure of beaches and dunes which protects a marsh and/or lagoon system from attack by oceanic waves (Figure 1). The key words here are "protect a marsh and/or lagoon" and this function separates the barrier beach from other types of beaches, such as those found at the base of glacial deposits or rocky cliffs. Within this basic form, three sub-types can be identified: bay barrier, spit, and barrier island. Of the three, the spit type barrier beach is most common in the glaciated regions of North America, and other similar coasts, while barrier islands are common south of that region. The best examples of barrier islands in the world can be found along the U.S. east and Gulf coasts from the south shore of Long Island, New York, to Mexico. Barrier spits are attached to a mainland or large island from which the sand that makes up the spit was derived by wave action, and wave-induced sand movement called "littoral drift". The bay barrier is a rather small barrier that forms between two rocky headlands or other land masses extending into the sea. These beaches are often at the head of a fiord, or bay, and usually form as waves move sand up to the head. They often have streams and marshes behind them, and thus fit the criteria of a barrier beach. Such beaches are found along rocky, indented shores. The best example in the NP System is "Sand Beach" in Acadia National Park, Maine.

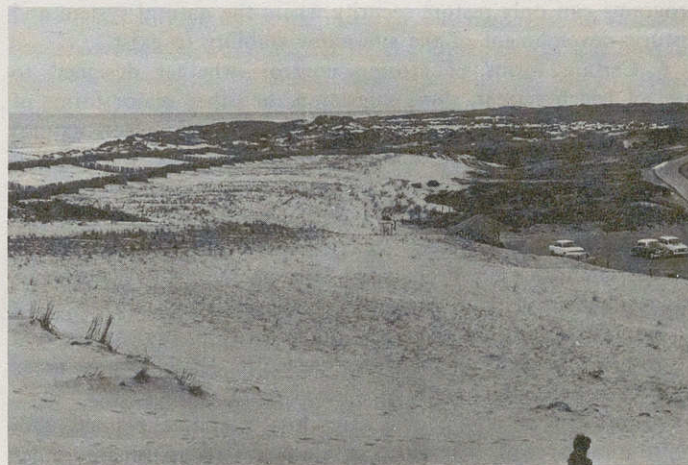
*Dune stabilization projects at the Kennemerduinen National Park in The Netherlands are visible at the left and center of this photo. Natural dunes are in the background. Photo: Paul J. Godfrey*

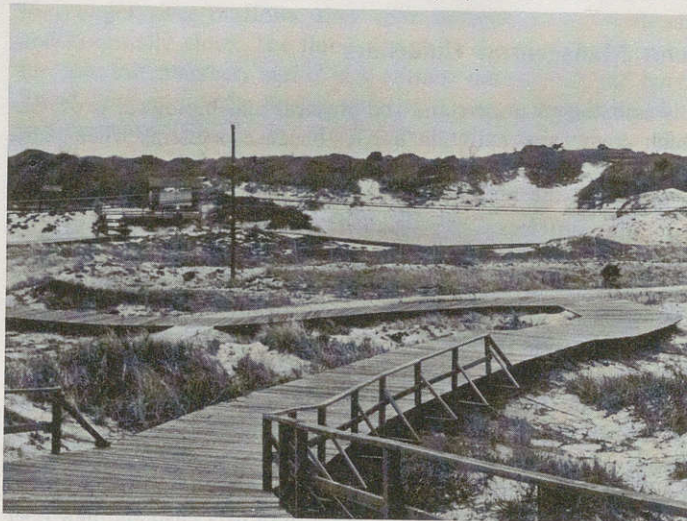
*A boardwalk built over the dunes at Fire Island National Seashore, New York, U.S.A. Where use is heavy, boardwalks will help control damage. Photo: Paul J. Godfrey*

2. Where heavy use is likely, wooden walkways and bridges over sensitive dune vegetation should be built over the dunes to the beach. Such elevated walkways are essential in wetland and salt marsh habitats. Good examples of elevated trail systems can be found on Fire Island National Seashore and parts of Cape Cod National Seashore. Most other parks which have heavy trail use are turning to elevated paths made of wood.

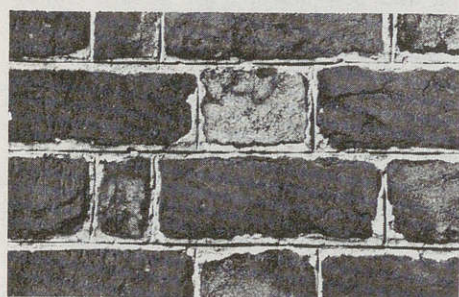
Figure 1. A variety of joint types and brick bonding patterns are illustrated here. Note the difference in uniformity of the bricks in A and B, which are handmade, and those from C through F, which are machinemade. It is evident in A, B, and F that the vertical joints were struck before the horizontal joints. Also note in B and E that the vertical joints are narrower than the horizontals.

A Colonial grapevine joint, Flemish Bond ca. 1720.

**Pointing styles** and the methods of producing them should be studied (Fig. 1). It is important to examine both the hori-

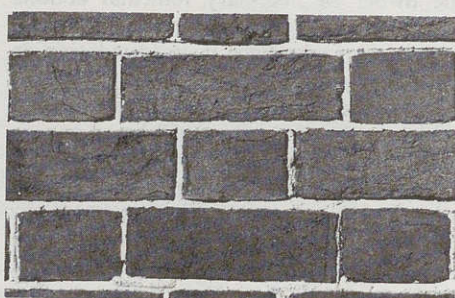
B Beaded joint, Flemish bond ca. 1809.

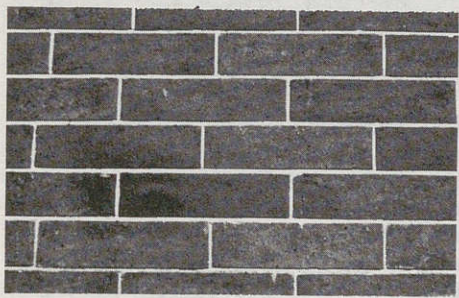
C Flush joint, common bond mid-19th century

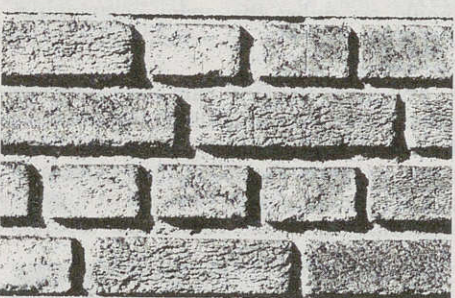
D Raked joint, English bond early 20th century.

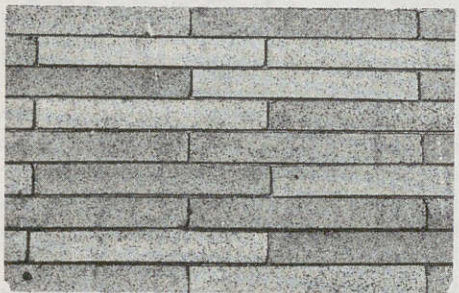
E Flush joint, one-third running bond early 20th century.

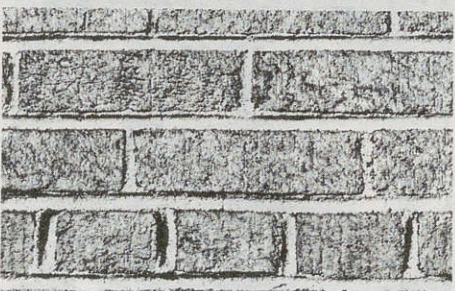
F Concave joint, common bond early 20th century.

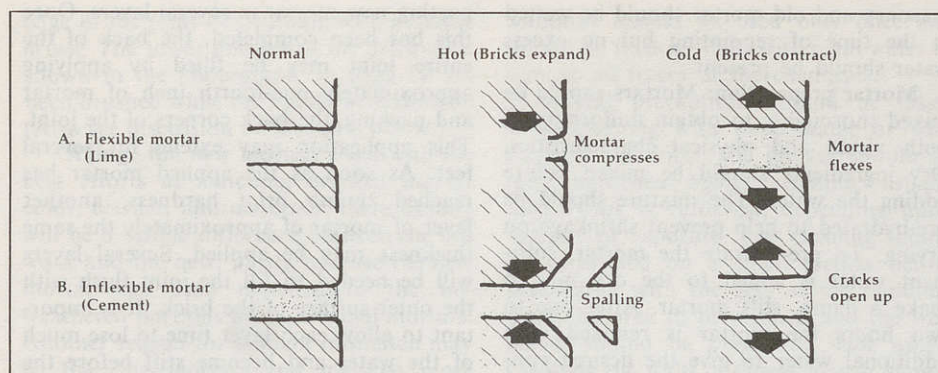
Figure 2. Diagrammatic sketches showing effects of temperature change upon masonry. Flexible mortar (A) expands and contracts with temperature changes. Bricks bonded by inflexible mortar (B) tend to spall at the edges (the area of greatest stress) in hot weather and separate from the mortar when it is cold. This latter condition opens cracks, permitting the entry of water and causing additional deterioration. Adapted from Maintenance of Old Buildings, Document D 10; National Swedish Institute for Building Research, Stockholm, 1975.

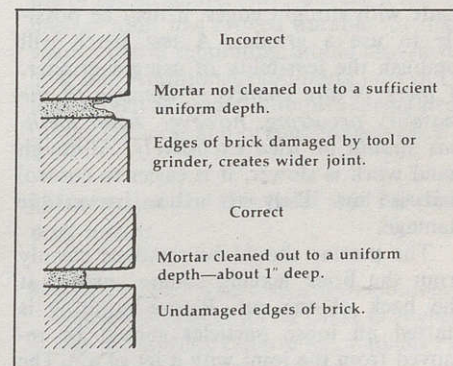
Figure 3. Comparison of incorrect and correct preparation of mortar joints for repointing.

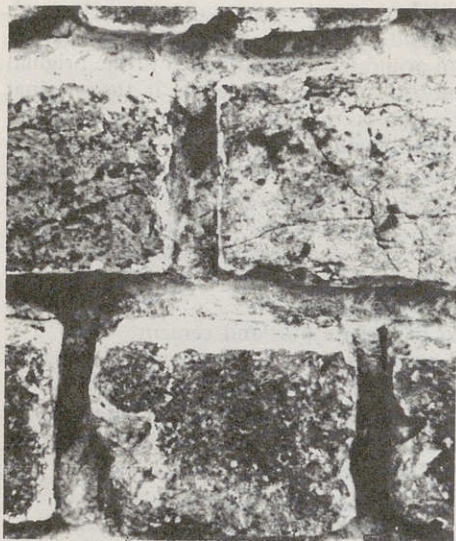
Figure 4. The damage to the edges and corners of these bricks was caused by using a power grinder in cleaning the joints. Extensive hand work is required to prevent damage to the bricks during joint preparation.

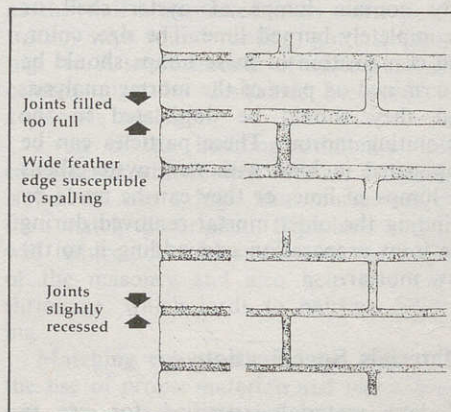
Figure 5. Comparison of visual effect of full mortar joints vs. slightly recessed joints. Filling joints too full hides the actual joint thickness and changes the character of the original brickwork.

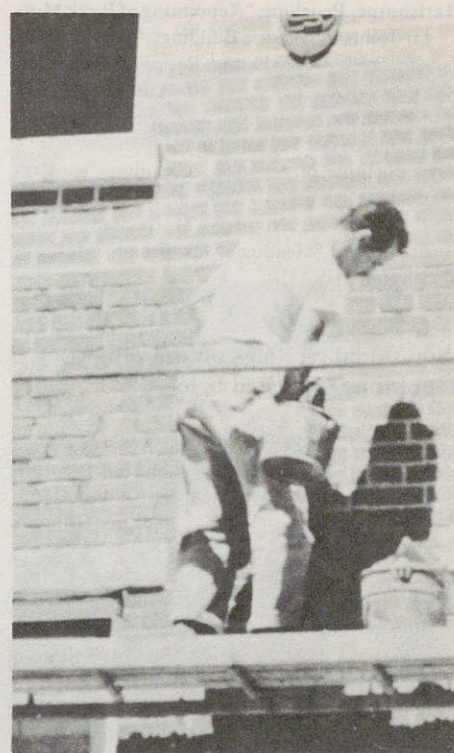
Figure 6. This photograph shows the significant visual changes which can result from improper repointing procedures. Note the increased thickness of the joints, the color variation, and the difference in the method of tooling, all noticeable even from a distance.

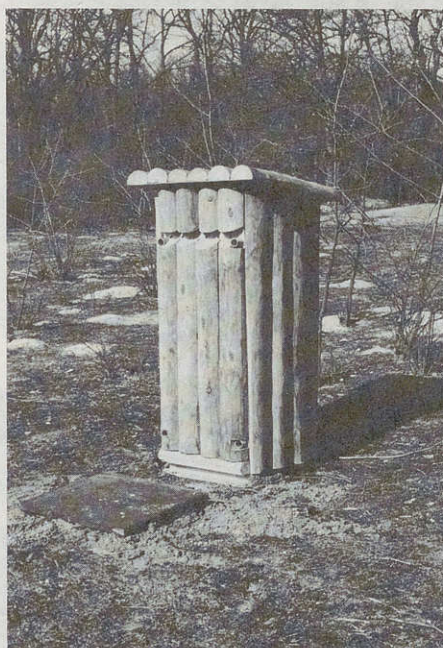
Information Box, ready for "use."

The door is fastened in the closed position by four round-headed bolts. When they are screwed tight, the heads are at the bottom of iron tubes. Unscrewing is possible only with the help of a special key: an iron tube with a cam welded on the inside that fits into a groove in the bolthead. Without that key it is impossible to open the door.

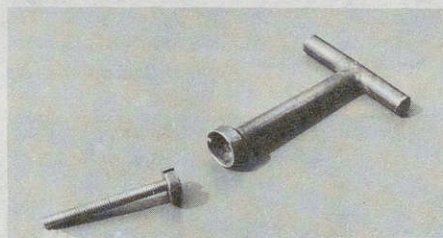
Bolt (one of 4) and special key wrench used to close and open the door.

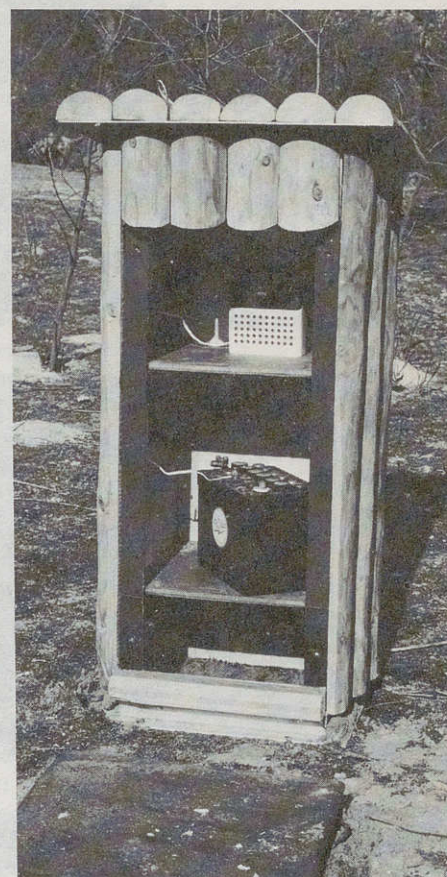
The Box with door removed to show battery and tape equipment.

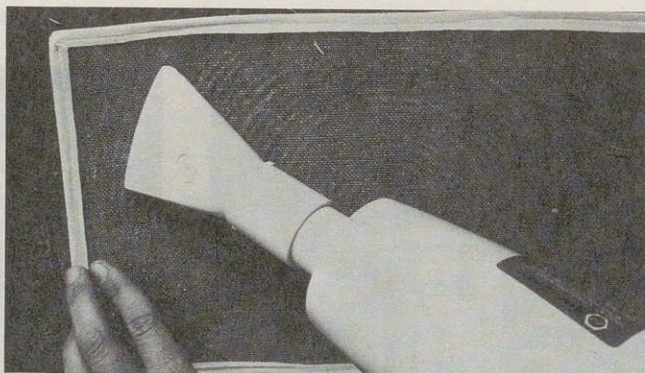
1. Recommended temporary cleaning procedure

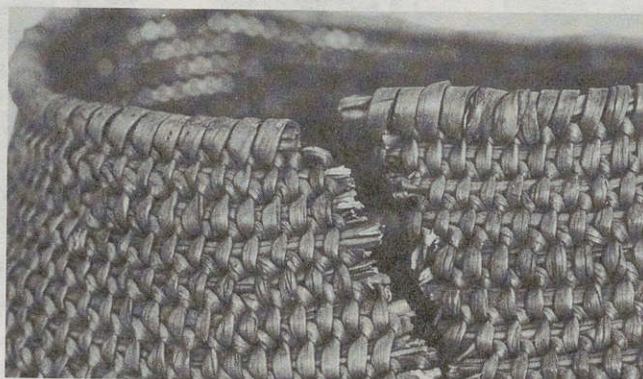
2. Typical damage-break

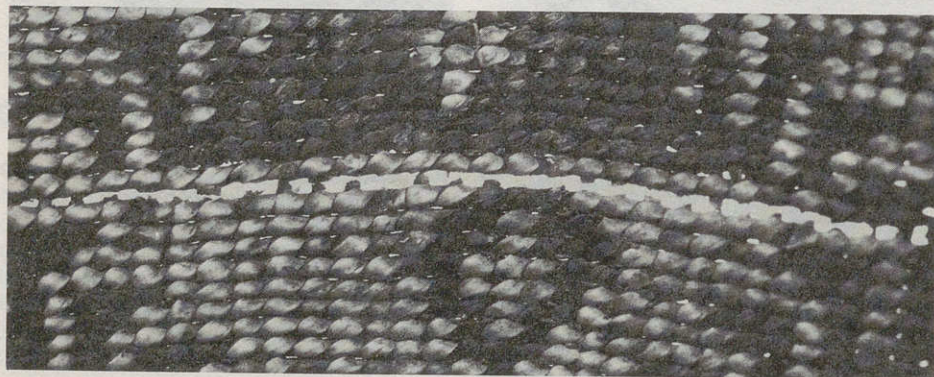
3. Typical damage-crack

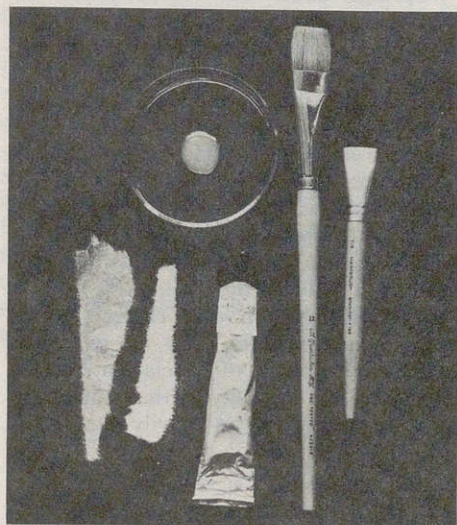
4. Equipment and materials for temporary repair process

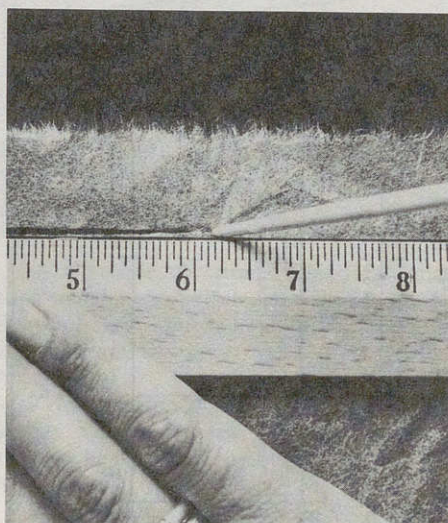
5. Scoring of mulberry tissue with wet, blunt instrument

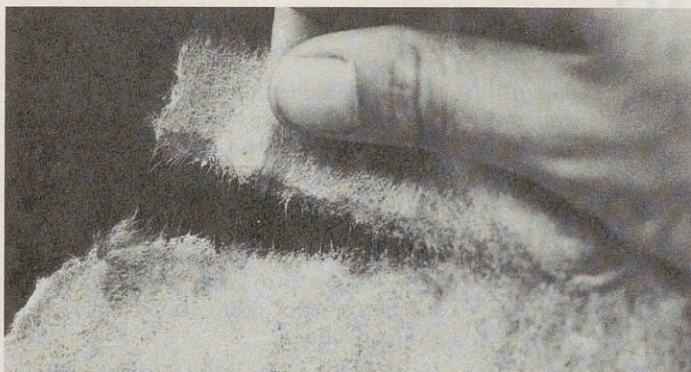
6. Proper tearing action of tissue

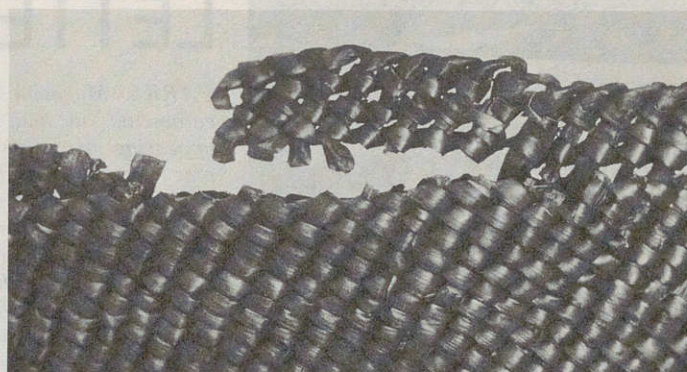
8. Weak area to be mended

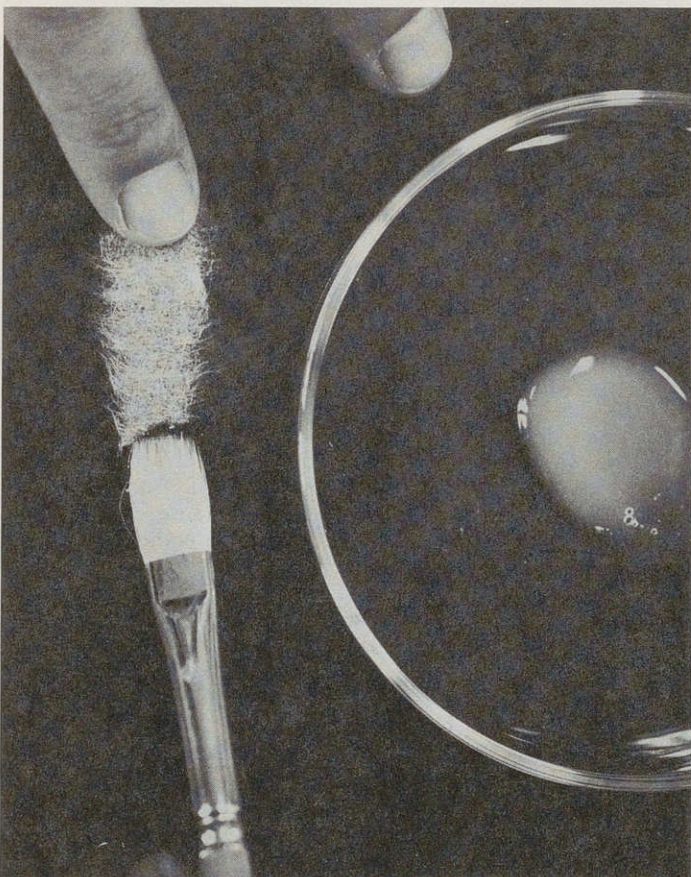
7. Application of paste to tissue

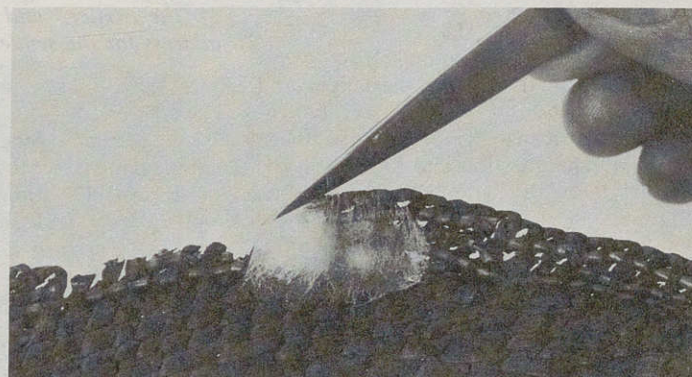
9. Application of moist tissue

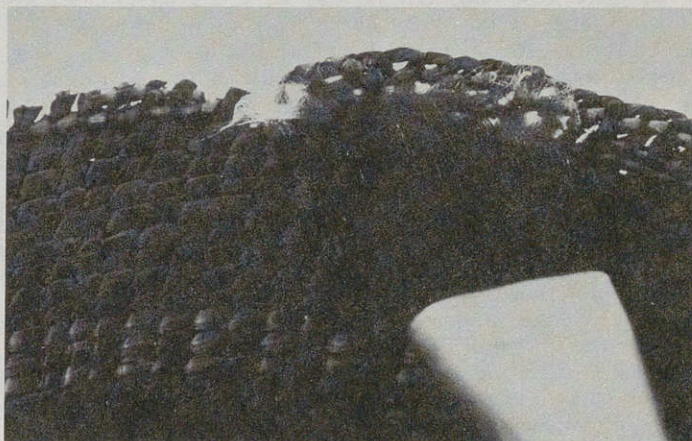
10. Tapping into place of tissue fibers with soft, dry brush

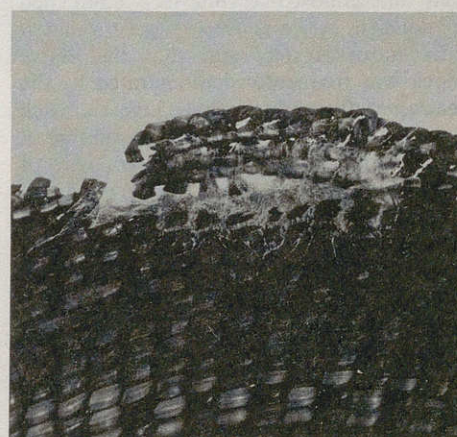
11. Finished mend—still damp  
Photos: Hali Taylor
